Manhole Inspection Summary

Manhole # S35MM_029MH

Insp Date: **3/6/07 8:59 AM**

Location Address: **310 21ST ST**

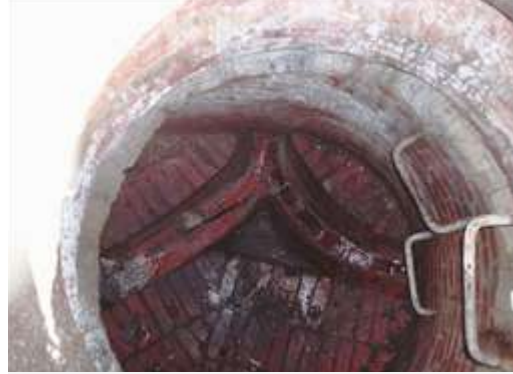
Top View

Bench and Channel debris.

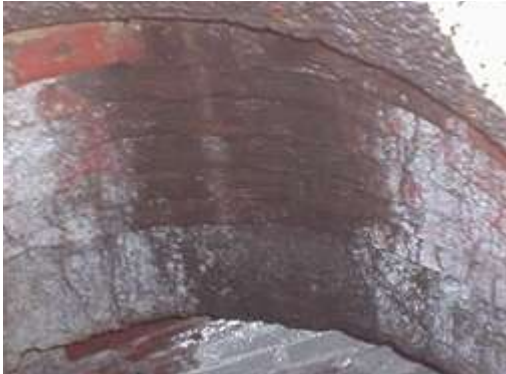
Defect

☒ **Leaks**

Infiltration: ☐ None ☒ **Joint** ☐ Cracks ☐ Mortar ☐ Roots ☒ **Wall**

Infiltration: ☐ None ☐ Joint ☐ Cracks ☐ Mortar ☐ Roots ☒ **Wall**

Frame leaks. Adjustment and Barrel infiltration.

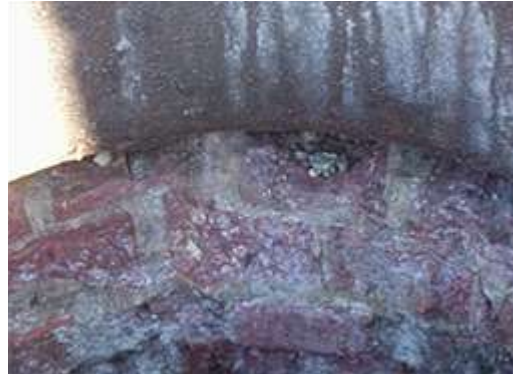
Defect

Condition: ☐ Sound ☐ Cracked ☐ Root Intrusion ☐ Loose Brick ☒ **Deteriorated**

Frame leaks. Adjustment deterioration and infiltration.

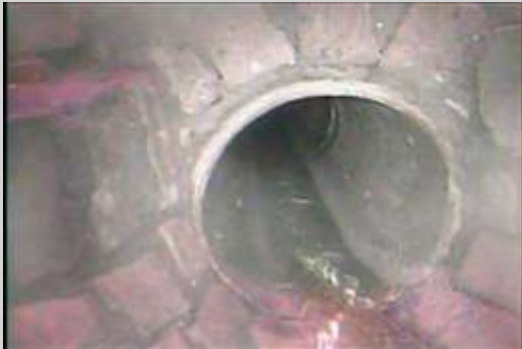
8 in. Circular Gravity Sewer Pipe Out @ 12 O'Clock

Deposits: ☒ None ☐ **Mud** ☐ Sludge ☐ **Debris** ☐ **Grease**

Infiltration: **None** Pipe Seal Cond: **Unknown**

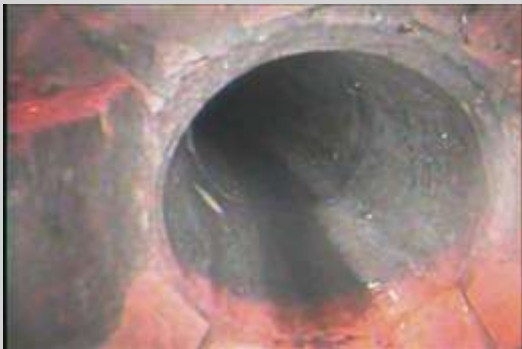
8 in. Circular Gravity Sewer Pipe In @ 3 O'Clock

Infiltration: **Evidence** Pipe Seal Cond: **Unknown**

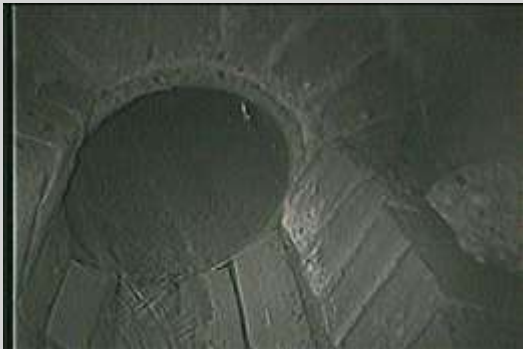
8 in. Circular Gravity Sewer
Pipe In @ 8 O'Clock

Deposits: ☐ None ☒ **Mud** ☐ Sludge ☒ **Debris** ☒ **Grease**

Silt Depth: **0** (in.) Deposits Extent: **Light**

Infiltration: **Evidence** Pipe Seal Cond: **Unknown**
